DOE/NASA/0600-79/1 NASA CR-159775 R-1575

DESIGN, FABRICATION, TEST, AND EVALUATION OF A PROTOTYPE 150-FOOT LONG COMPOSITE WIND TURBINE BLADE

Herbert W. Gewehr Kaman Aerospace Corporation Approved for public release
Distribution Unlimited

September 1979

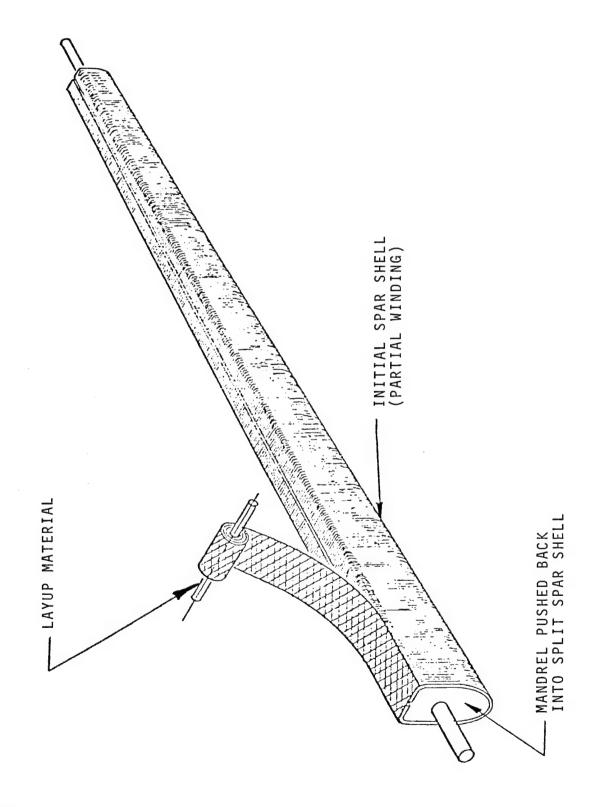
Figure 62. Repair of Spar Shell Aft Web.

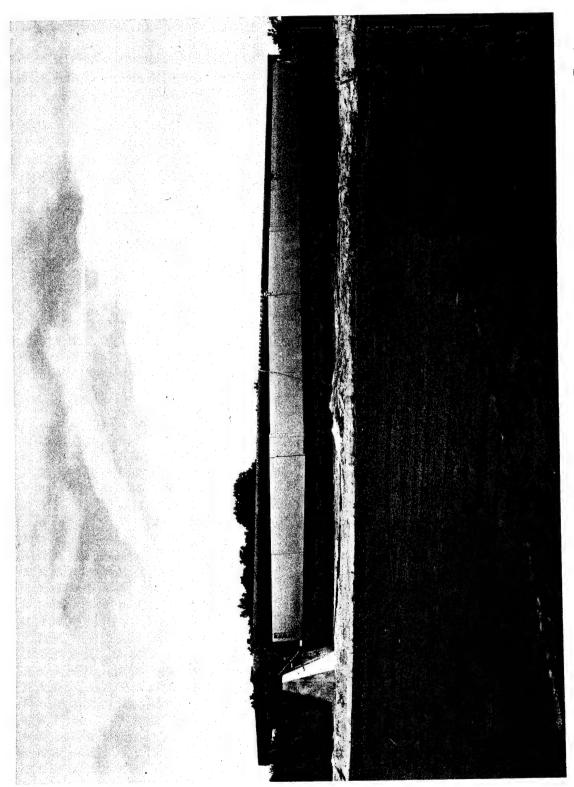
Figure 75. Test Set Up for Natural Frequency Tests, Flatwise and Edgewise Stiffness Tests, and Edgewise Bending Test to Design Limit Load.

Measured edgewise frequencies were higher than predicted due to the edgewise stiffness being greater than predicted, as shown in Figure 6. A similar result would be expected for flatwise frequencies for the same reason. However, it is suspected that measured flatwise and torsion frequencies were lower than predicted as a result of lateral flexibility in the test support structure illustrated in Figure 75.

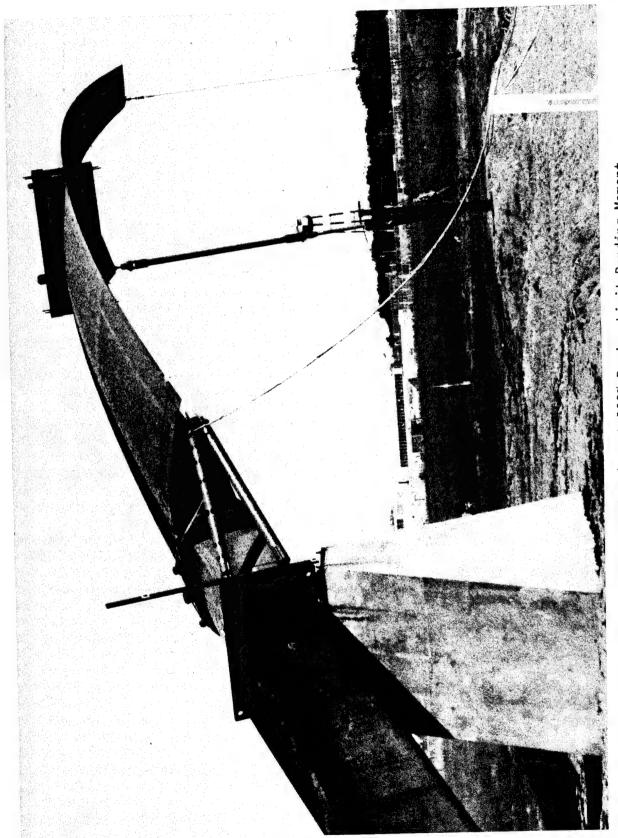
Figure 80. Flatwise Deflection at 100% Design Limit Bending Moment.

After completion of the natural frequency and stiffness determinations, and the edgewise test to design limit load, the blade was repositioned as shown in Figure 79 for the flatwise tests. The blade was tested to design limit load in the flatwise direction, Figure 80, and then taken to failure which occurred at 9 percent above design limit load, Figure 81. Failure occurred at blade station 45, Figures 82 and 83, as local crippling at a flaw in the spar laminate. Although the flaw was detected in the surface of the spar during the NDI process, its effect on crippling strength was not recognized. Subsequent investigation revealed that the flaw was a local bulge in 60 percent of the spar wall thickness, resulting from the four step winding process and the associated soft tooling. Future blades will be made in a single step with improved tooling to eliminate such flaws.

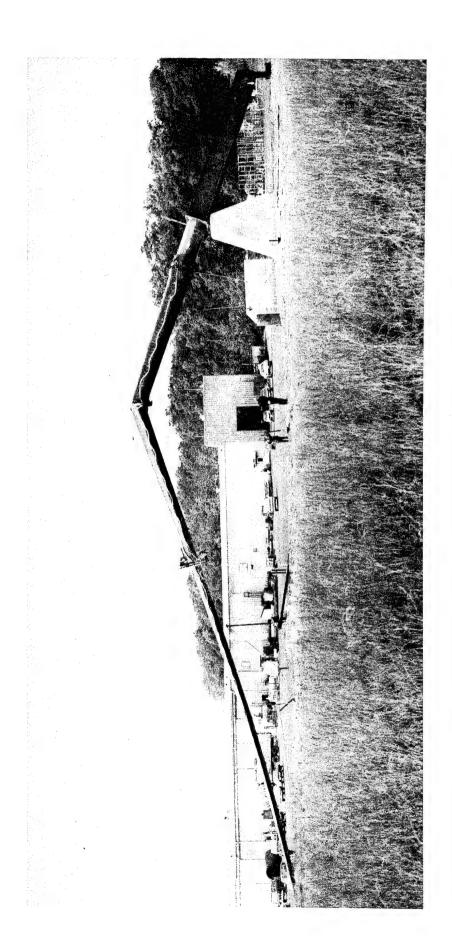
Figure 82. 150 Foot Blade After Failing Load Test.

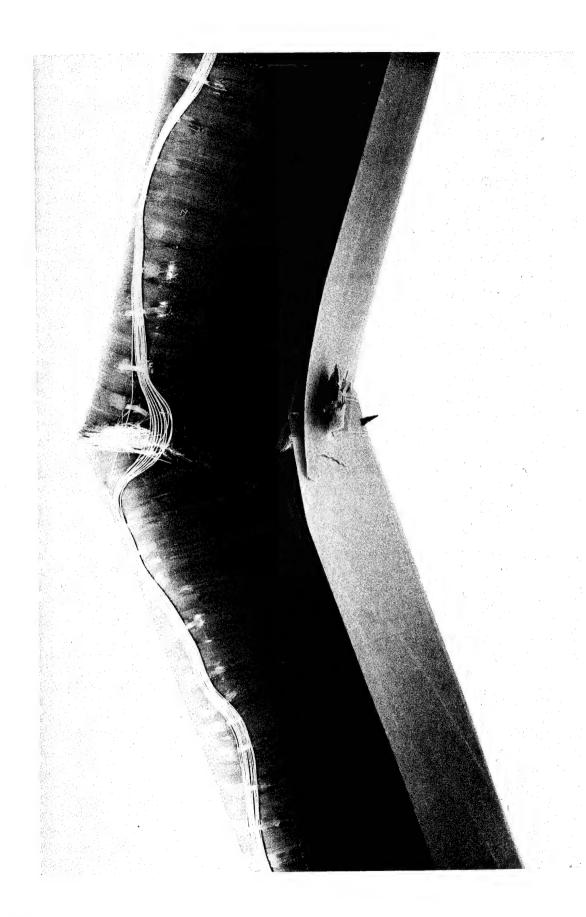
scale blade tests were performed which included natural frequency tests, deflection and stiffness measurements, proof load tests, and a flatwise bending test to failure. Failure occurred by local crippling of the spar wall at 109 percent of the design load (a hurricane wind condition, 164 mph at rotor hub height). The origin of the crippling failure was a flaw in the spar wall associated with the prototype fabrication process and soft tooling peculiar to this one-of-a-kind wind turbine blade. A subsequent test of the surviving outboard end of the blade (100 ft long) successfully sustained a flatwise bending moment almost 3 times the design load. This later test demonstrated that large knockdown factors from theoretical crippling strength predictions are not necessary for pure monocoque glass/epoxy structures of this type providing no serious material defects (such as the visible flaws present at the location of the crippling failure) are present.

Figure 83. Crippling Failure of Blade Spar.

This test demonstrated that large knockdown factors from theoretical crippling strength predictions are not necessary for pure monocoque glass/epoxy structures of this type, provided no serious material defects (such as the local bulges present at the station 45 failure location) are present.

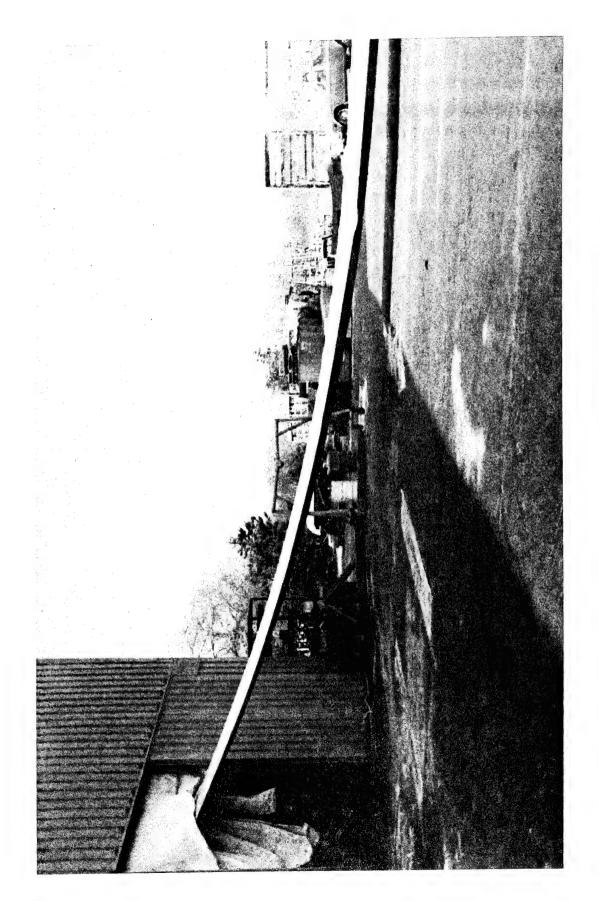
Figure 84. Blade Deflection at Approximately 15,000 Pounds Tip Load, Second Buckling Test.

Subsequent to the ultimate load test of the complete blade, the outboard 100 ft of blade was still structurally intact, so it was set up and tested in flatwise bending as a simply-supported overhanging beam, Figure 84. The test section from station 90 to 150 had none of the local flaws observed in the inboard region of the spar where the previous test had resulted in failure.

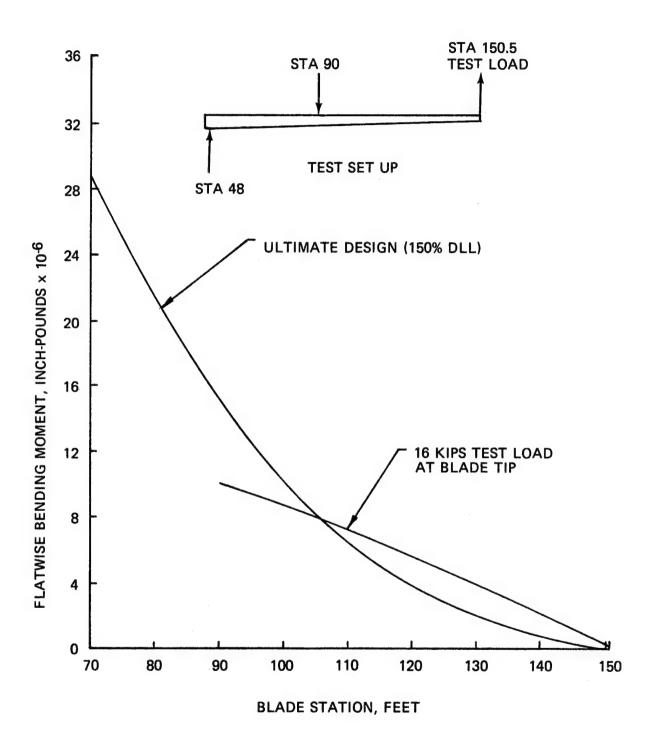
Figure 85. Bending Moments for Simple Cantilever Buckling Test of 150 Foot Blade Section.

The outboard test section successfully sustained bending moments in excess of the ultimate design condition (defined as 1.5 times design limit) from blade station 106 to the tip. At blade station 130, the applied moment was 2.8 times design limit, Figure 85, well above the predicted buckling strength of the spar wall.
